# SOLAR WAREHOUSE MIAMI-DADE TEST REPORT

TAS 100(A)-23 TESTING ON SWH PV MOUNTING SYSTEM

R5185.01-109-18

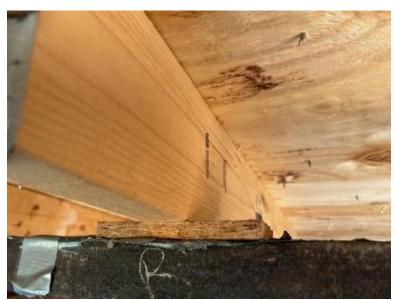
Photo No. 2 Underside Before Testing

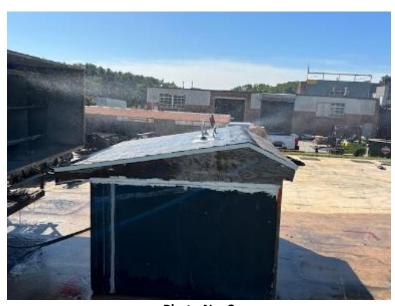
Photo No. 3 35 MPH Top Side

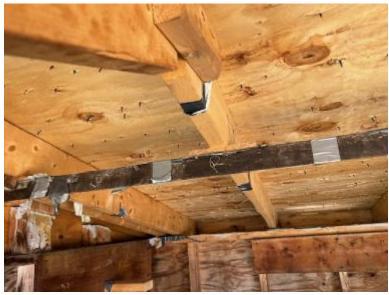
Photo No. 4 35 MPH Underside

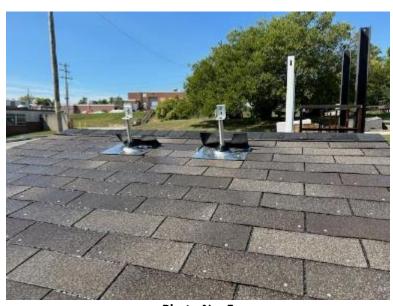
Photo No. 5 70 MPH Top Side

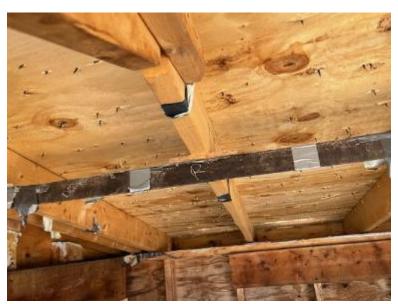
Photo No. 6 70 MPH Underside

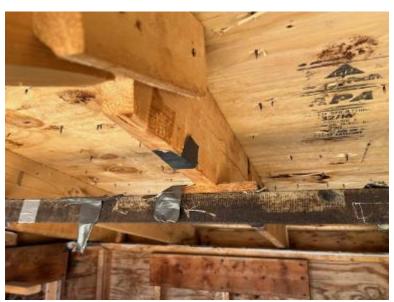
Photo No. 8 90 MPH Underside

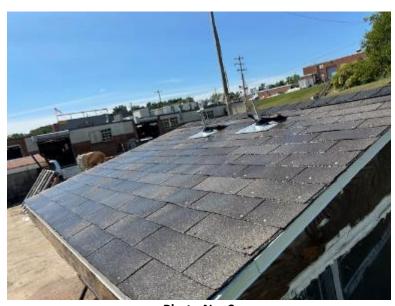
Photo No. 9 110 MPH Top Side

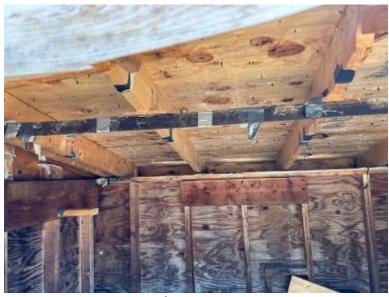
Photo No. 10 110 MPH Underside

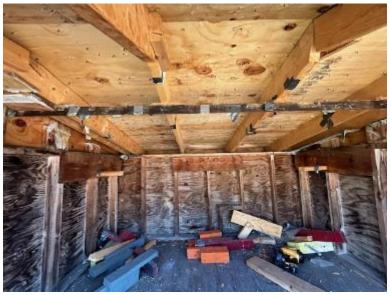
Photo No. 12 Post Test Underside
